Structural Engineer's Appraisal  
Covent Garden Car Park  
Warwick District Council

Issue Number P02  
02.08.2022

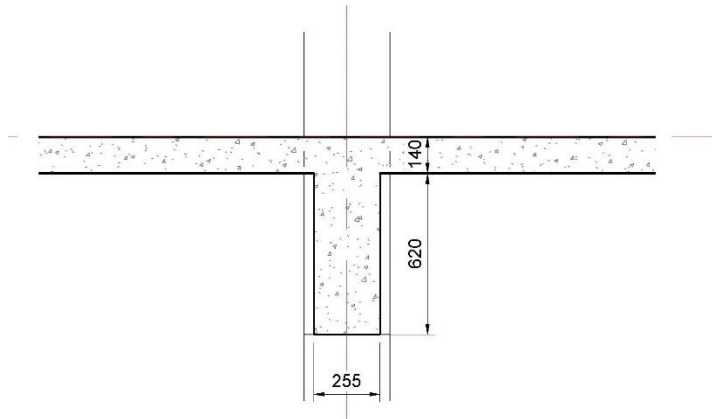
Figure 1 - Flanged Beam Section

Each structural deck is formed by in situ concrete slabs 140mm thick, spanning between 760 x 255mm primary down-stand concrete beams at approximately 4525mm centres. The beams span 15.9m between concrete columns.

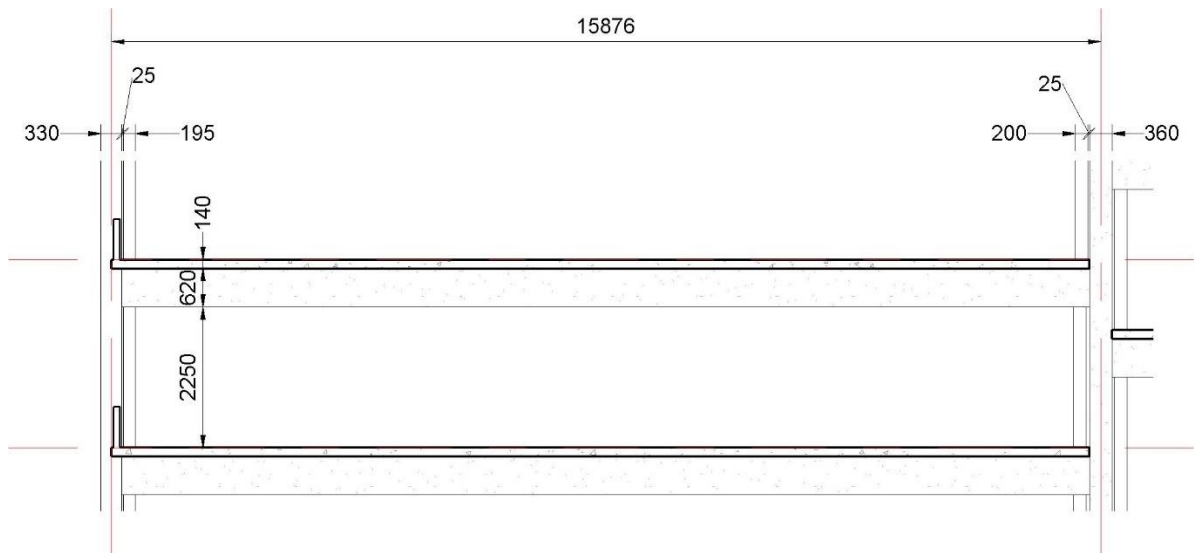
Figure 2 - Flanged Beam Elevation

There are cracks in the column heads which would appear to have resulted in the original columns being strengthened with newer column located in the same plane as the primary beams. This was perhaps carried out after overstressing of the structure was identified at some time in the past. There are also cracks located in the down-stand beams caused by overstressing.

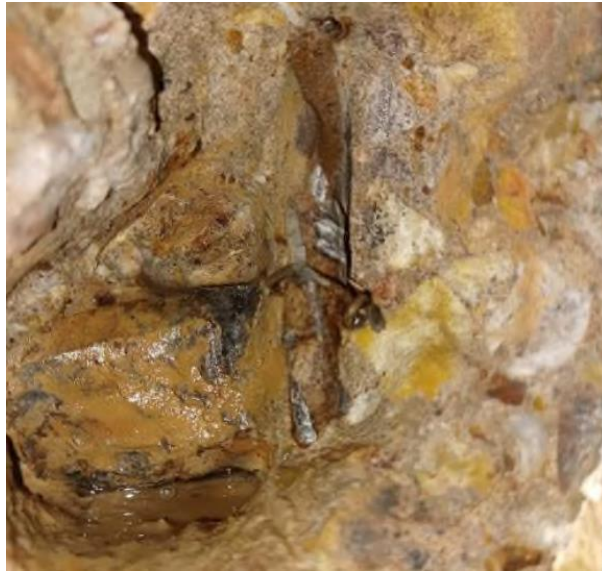
Figure 3 - Beam Bottom Reinforcement

Figure 3 shows shear links running from top to bottom of image and flexural reinforcement left to right of image. Shear links are 8mm smooth round bars, Flexural reinforcement is 30mm square twisted bar.

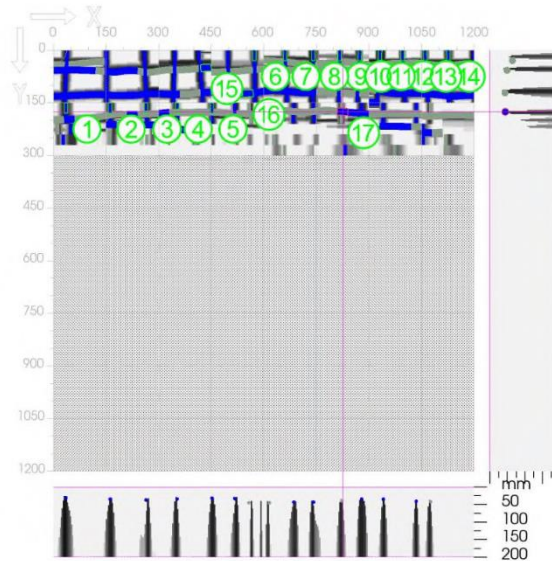
Figure 4 - Ferrous Scan Beam Soffit

Figure 4 shows shear links, bars 1-14 at approximately 100mm spacing. 3 number flexural reinforcement bars 15,16 and 17.

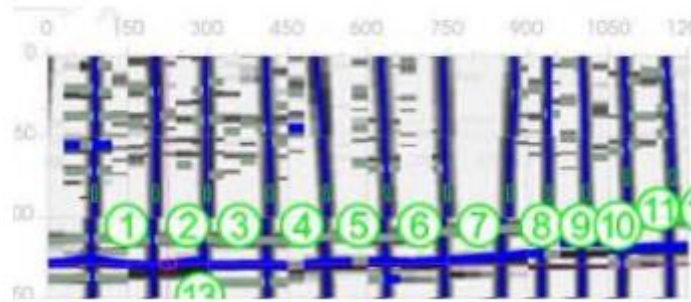
Figure 5 - Ferrous Scan Beam Face

Figure 5 shows shear links, bars 1-14 at approximately 100mm spacing. Bar 13 flexural reinforcement, only one flexural reinforcement bar is visible due to the plane from which the ferrous scan is taken.

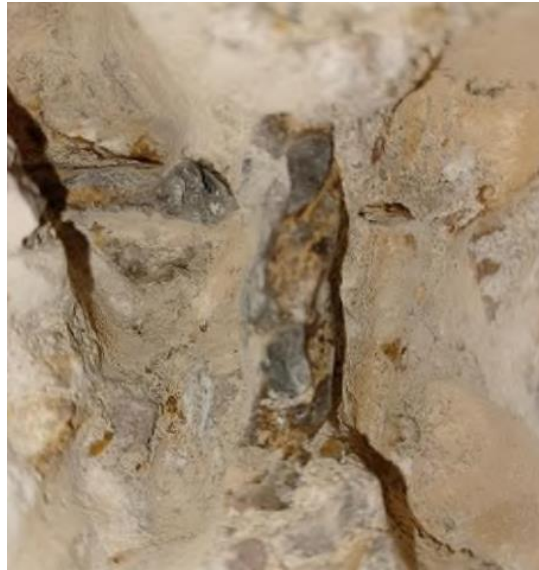
Figure 6 - Slab Soffit Reinforcement

Figure 6 shows 9mm square twisted primary reinforcement running top to bottom of the image. 7mm square twisted secondary reinforcement running left to right

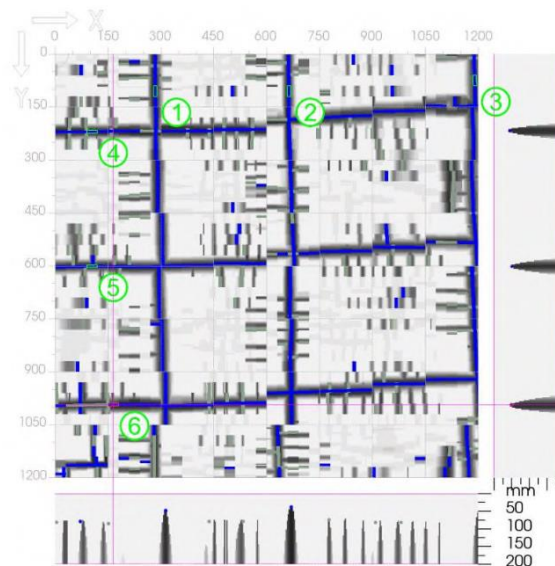
Figure 7 - Ferrous Scan Slab Soffit

Figure 7 shows primary and secondary slab reinforcement within the slab soffit at 450mm spacing in both directions.

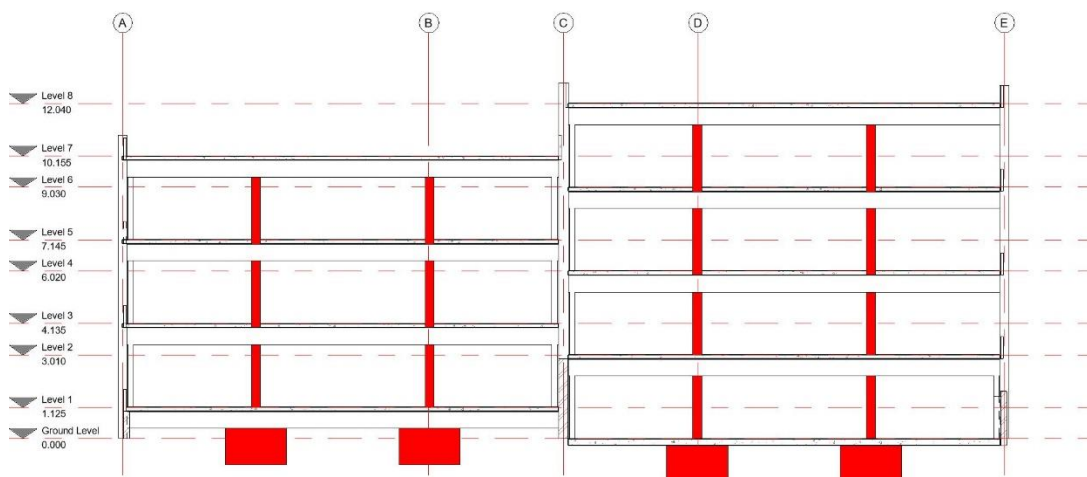
Figure 9 - Proposed columns and foundation in red

The existing structure could be strengthened with the introduction of columns to the end of the parking bays on the same 4500mm grid as primary structure, shown in Figure 9

The concrete decks and ramps could be strengthened with the addition of carbon fibre to the soffit.
