Structural Inspection Report  
of  
Covent Garden Multi Storey Car Park  
Warwick District Council

Issue Number 01

I.4 Inspected Property : Multi-storey car park  
Covent Garden  
Russell Street  
Leamington Spa

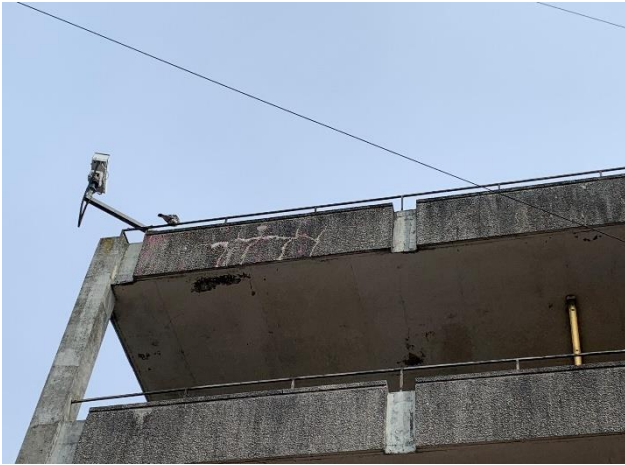
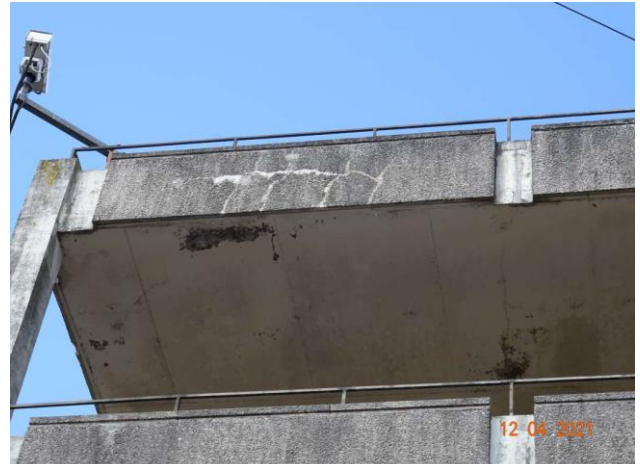
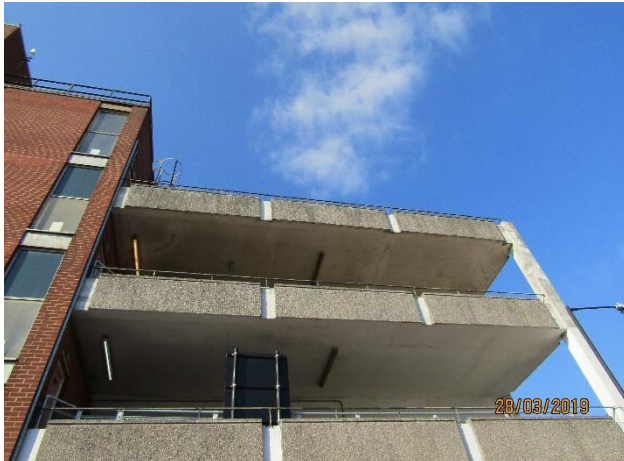
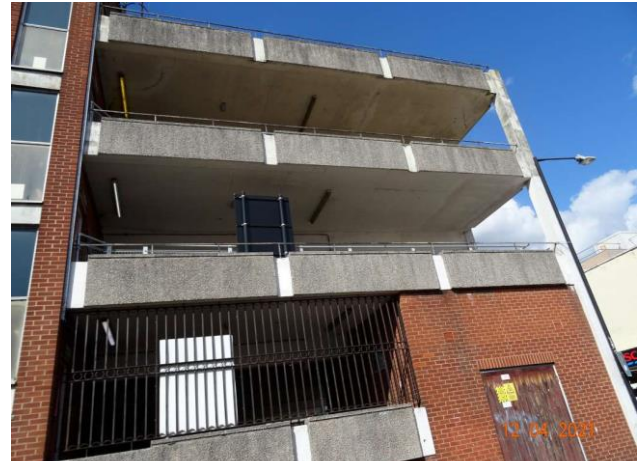
- 5.1.1.1 Inspection of the North elevation and specifically the areas showing crazed cracking, which indicates Alkali Silica Reaction. We have observed no change from the current inspection of the insitu and precast panels when compared against the last inspection in March 2019. **(Photograph No. 1 – 4)**

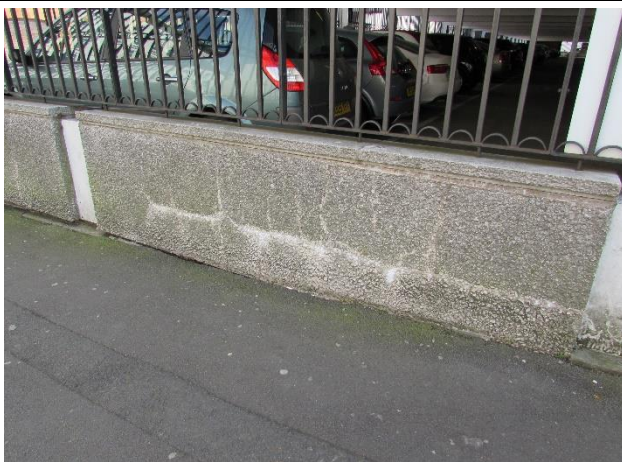
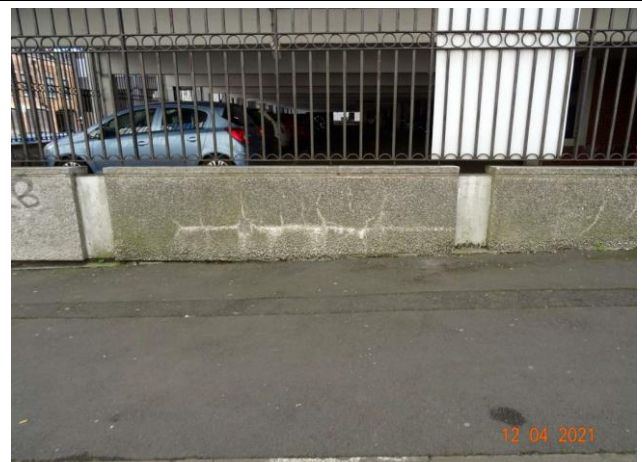
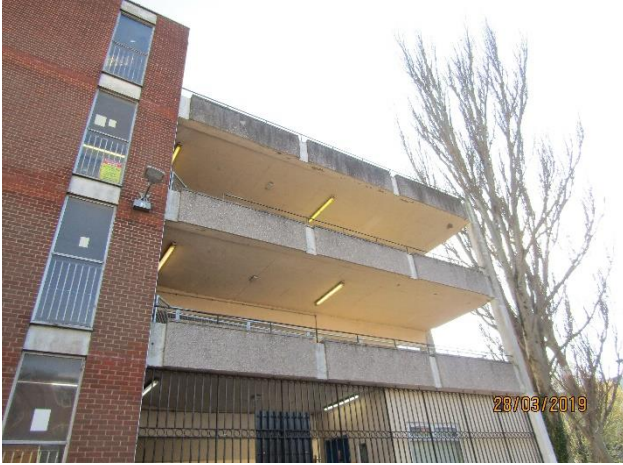
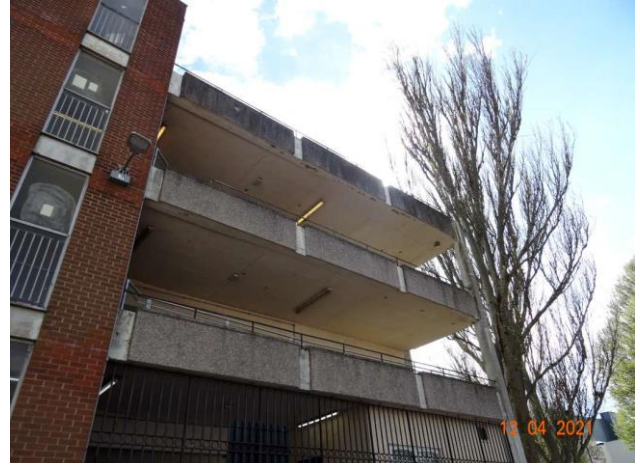
- 5.1.2.1 Inspection of the South elevation and specifically the areas showing crazed cracking, which indicates Alkali Silica Reaction. We have observed no change from the current inspection of the insitu and precast panels when compared against the last inspection in March 2019. **(Photograph No. 5-8)**

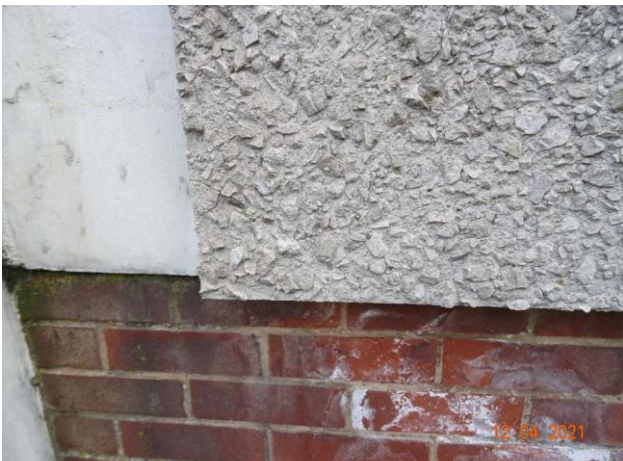
**Photo No. 9**

- 5.1.3.1 Slight diagonal cracking observed in some of the ground floor precast cladding panels. **(Photograph. No 9)**
- 5.1.3.2 Corrosion staining observed in several external locations at ground level adjoining the columns, suggesting water ingress and internal reinforcement corrosion. **(Photograph. No 10)** The corrosion staining appears to occur to numerous insitu concrete perimeter walls all along the East Elevation.
- 5.1.3.3 Slight diagonal cracking in the insitu parapet wall adjoining the column was observed in various locations. **(Photograph. No 11).**
- 5.1.3.4 Slight horizontal/diagonal cracking observed to the outer face on several the columns along the elevation. The cracking appears most evident to the top of the columns to level 4 and above, which is currently undecorated.

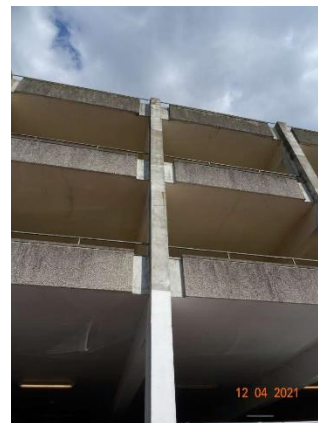
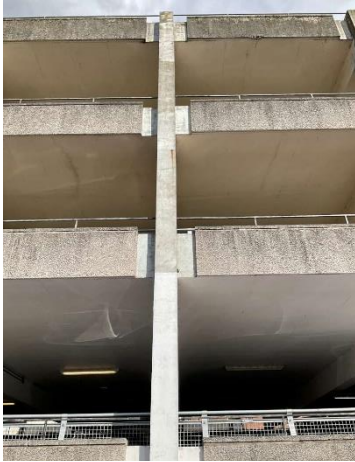
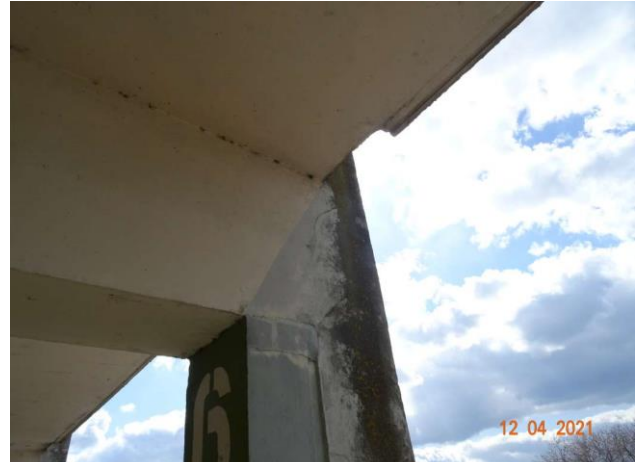
- 5.1.5 Slight horizontal/diagonal cracking observed to the outer face on several the columns along the elevation. The cracking appears most evident to the top of the columns to level 4 and above, which is currently undecorated **(Photograph. No 12-14).**

Numerous slight horizontal and diagonal cracking was evident to the external face of the columns from level 4 upwards. This may be a result of possible carbonation of this area, as it is not evident to the lower levels which appear to have been protected with a protective coating. The protective coating has been applied to level 0 to 4 only. Cracking at the top of the column to level 4 and above could also be a sign of stress and yielding and could be a potential structural issue. As such these should be monitored monthly for up to a year to measure if there is any ongoing movement.

Risk – **Red**, the cracking should be monitored to see if the cracks are progressively worsening. This should be carried out prior to any other major remedial works.

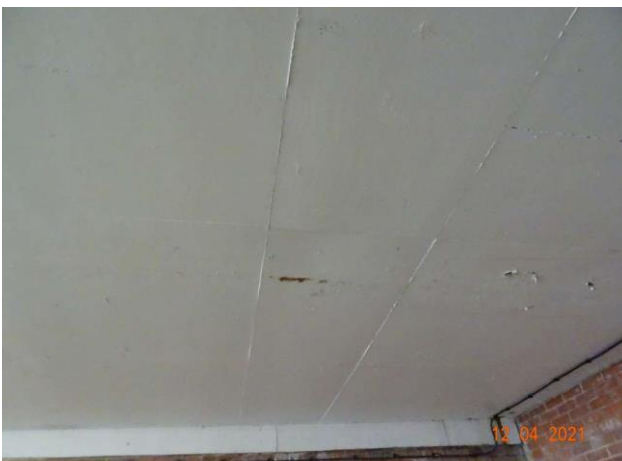
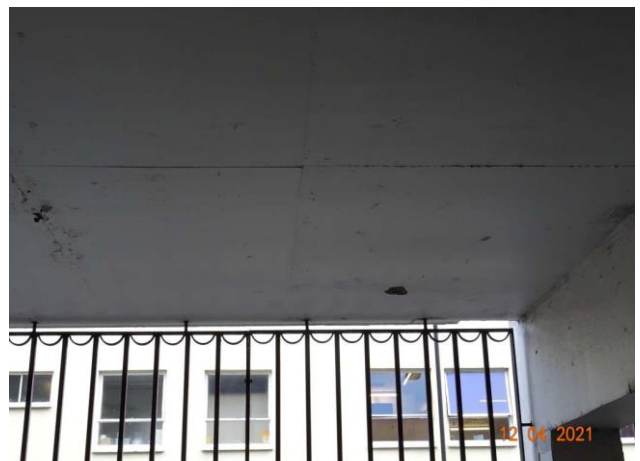
- 5.2.2.1 Similar extensive minor corrosion staining was noted throughout the soffit to the floor above. The amount of staining was not considered significant but is indicative of ongoing corrosion of the steel reinforcement to the floor above.
- 5.2.2.2 As well as corrosion staining, minor spalling was evident to various areas of the soffit and to the external and internal parapet walls **(Photograph. No 17-18)**.

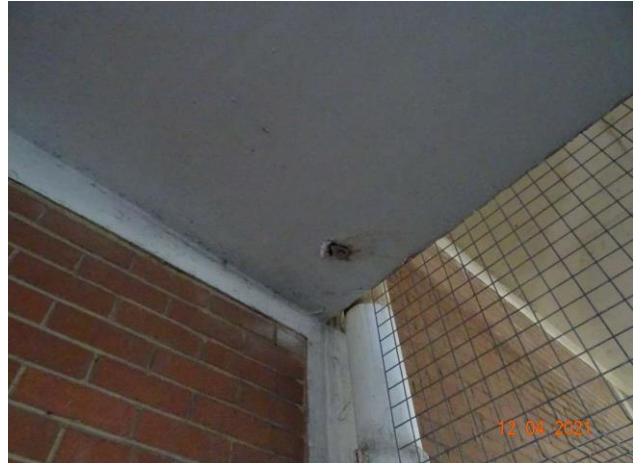
**Photo No. 20**

- 5.2.3.1 To the soffit of level 2, there was no significant change in the condition of the existing crack, and only a few minor new corrosion stains evident. The number of corrosion stains appears to be significantly less than what was viewed on the ground and first floor to the soffits. **(Photograph. No 19)**
- 5.2.3.2 To the soffit of level 3, slight cracking and corrosion staining were most evident to the soffit of the ramp in the centre of the structure and the ramp leading up to level 4. **(Photograph. No 20)**

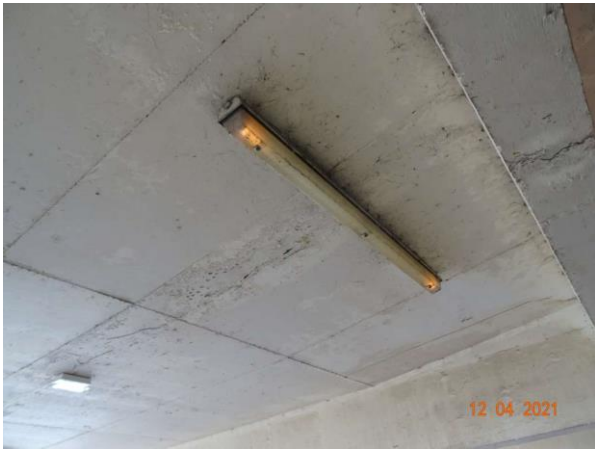
**Photo No. 25**

5.2.4.5 Numerous new locations of corrosion staining were evident to the soffit viewed on level 4.  
**(Photograph. No 25)**

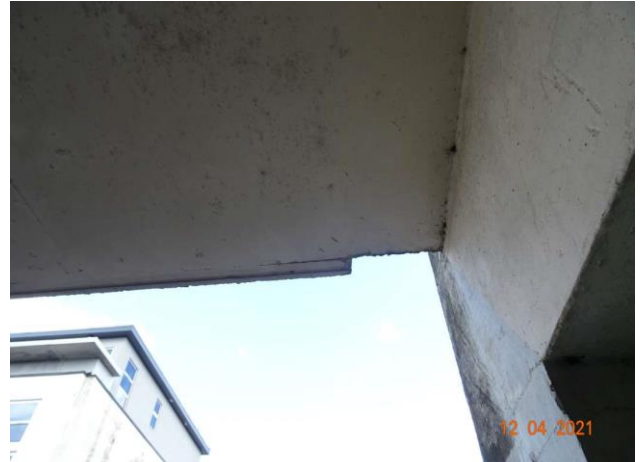
**Photo No. 26**

5.2.4.6 Slight horizontal cracking is evident between the external precast cladding panel and the insitu concrete parapet wall behind the outer perimeter on level 4 and 5. **(Photograph. No 26)**

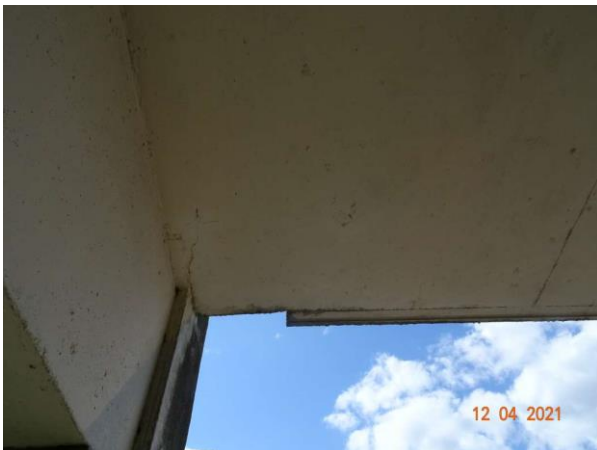
**Photo No. 27**

5.2.5.1 Several new slight horizontal and diagonal cracks are now evident to the external outside face of some of the columns on both level 4 and 5 **(Photograph. No 27)**

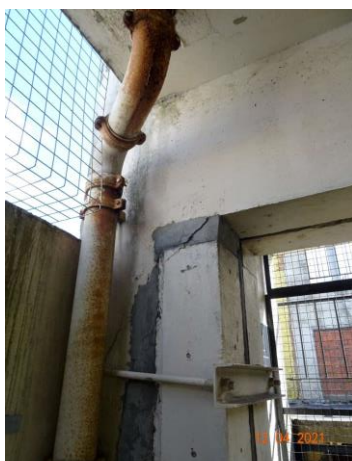
**Photo No. 29**

5.2.5.3 Failure of a localised repair and grout infill to the head of a column in the centre of the floor between level 6 and Level 7. **(Photograph. No. 29)**

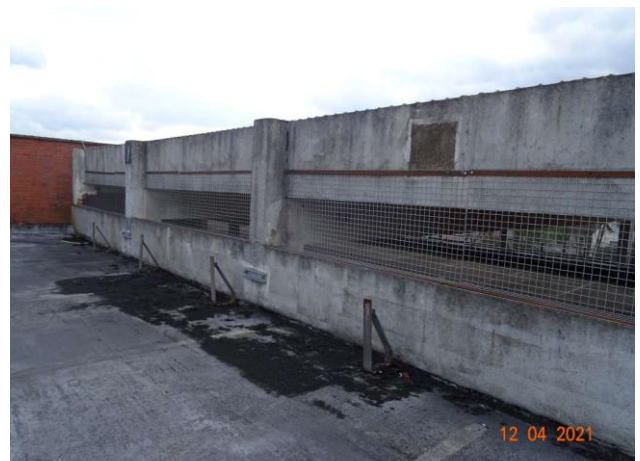
**Photo No. 30**

5.2.6.1 Previous crazed cracking observed in the external precast parapet walls is potentially caused by ASR, see section 4.4.6. However, visually the cracks do not appear to have deteriorated since our last inspection.  
**(Photograph. No 30)**

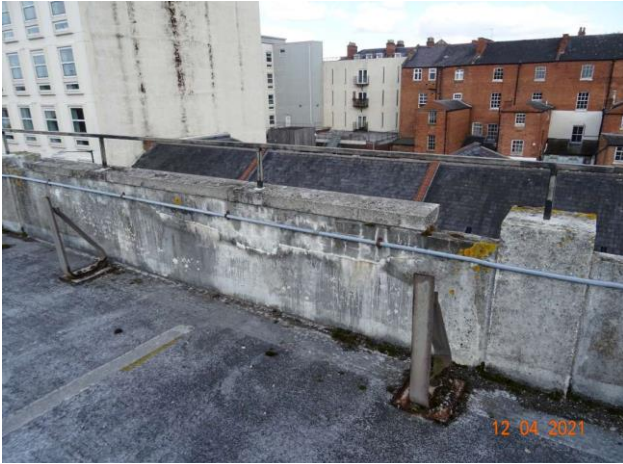
**Photo No. 31**

5.2.6.2 All the metal support frames that hold the pedestrian restraint mesh to prevent access to the top level are covered with surface corrosion. **(Photograph. No 31)**

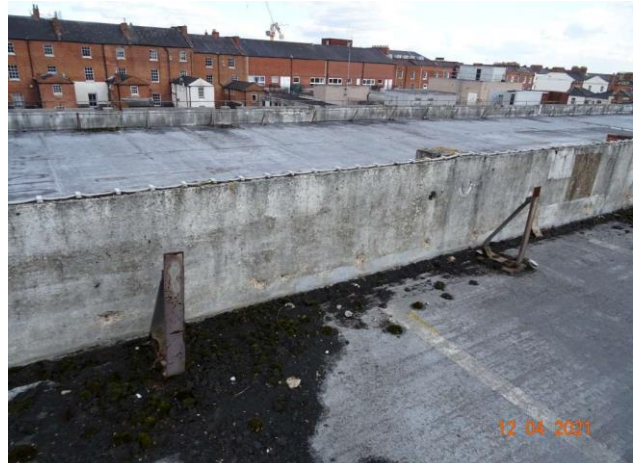
**Photo No. 32**

5.2.6.4 Extensive spalling on the internal insitu parapet wall between Level 7 and 8. The spalling appears to correspond to the fixings for the Pedestrian mesh fixed to the face of the internal parapet wall on Level 7.  
**(Photograph. No 32)**

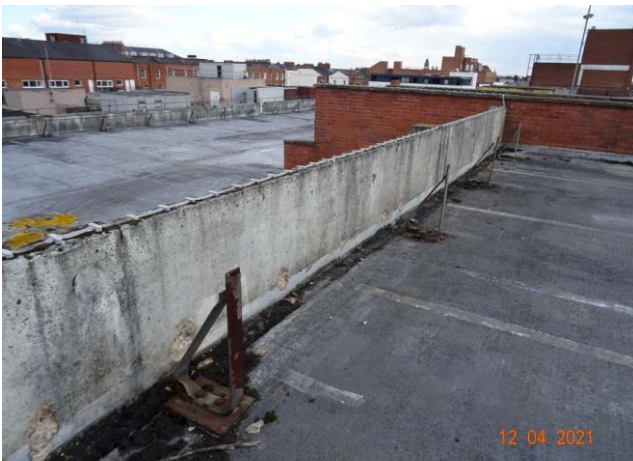
**Photo No. 33**

5.2.6.5 The crash barriers to the top decks are in poor condition, with extensive failure of the plastic coating and corrosion of the barriers. **(Photograph. No 33)**

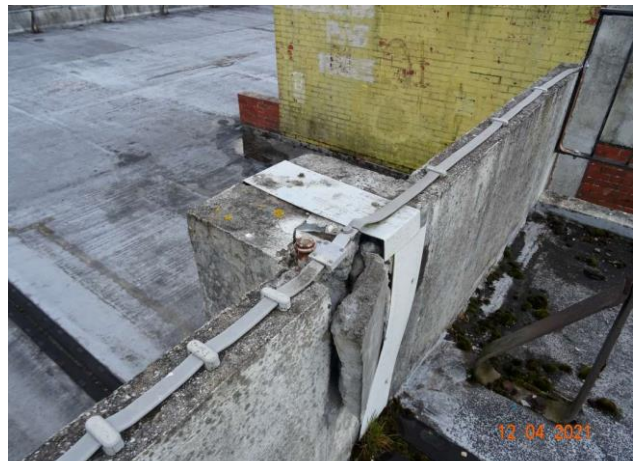
**Photo No. 34**

5.2.6.6 The head of one column appears to have spalled in the centre of the building to Level 8. This appears to have been caused by corrosion of an embedded fixing to the head of the column or possible ASR.  
**(Photograph. No 34)**

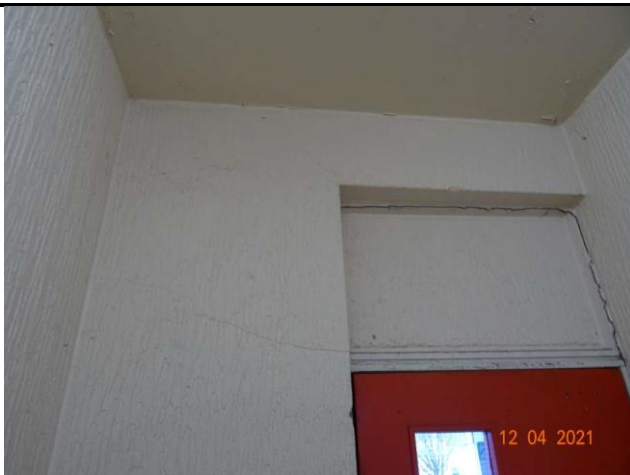
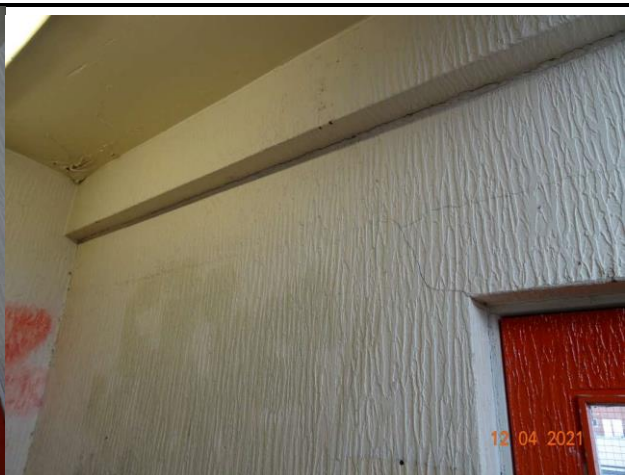
- 6.2.1.1 Some slight to moderate cracks are evident both to the external brick face and internal blockwork to both the north and south stairwells (**Photograph. No 35-36**). Of the two enclosed stairwells, the cracking in the southern stairwell appears to be more numerous, suggesting the cracking is thermal due to its southerly exposure.
- 6.2.1.2 The damage observed within the stairwells did not appear to be structurally significant, with the defects observed being attributed to the normal thermal movement in the blockwork and between pre-cast concrete panels and general wear/weathering.
- 6.2.1.3 Spalling to the soffit of the stairs observed to level 2 to the South Elevation, this should be repaired in the short term. (**Photography. No 37**)

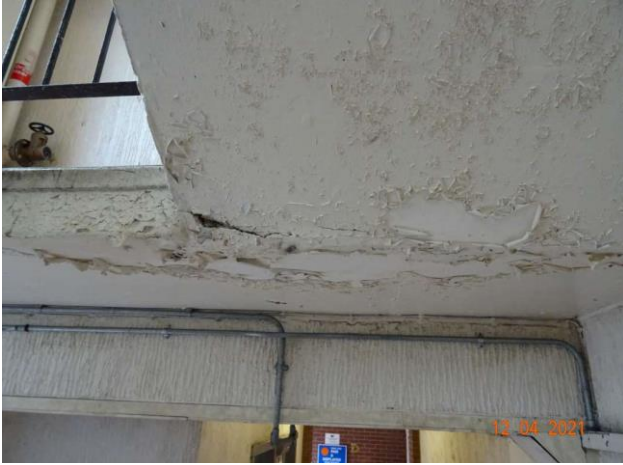
**Photo No. 37**

**8.1.6** Spalling to Soffit of stairwell (South) see photograph 37.

Risk **Red** – Risk of further spalling concrete or failure or closure of staircase. Repair as soon as possible to prevent deterioration.
