Structural Inspection Report  
of  
Covent Garden Multi Storey Car Park  
Warwick District Council

Issue Number 01

I.4 Inspected Property : Multi-storey car park  
Covent Garden  
Russell Street  
Leamington Spa

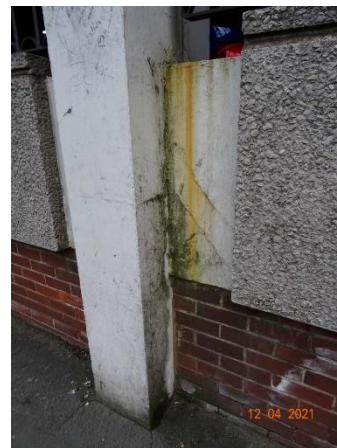
**Photo No. 9**

- 5.1.3.1 Slight diagonal cracking observed in some of the ground floor precast cladding panels. **(Photograph. No 9)**
- 5.1.3.2 Corrosion staining observed in several external locations at ground level adjoining the columns, suggesting water ingress and internal reinforcement corrosion. **(Photograph. No 10)** The corrosion staining appears to occur to numerous insitu concrete perimeter walls all along the East Elevation.
- 5.1.3.3 Slight diagonal cracking in the insitu parapet wall adjoining the column was observed in various locations. **(Photograph. No 11).**
- 5.1.3.4 Slight horizontal/diagonal cracking observed to the outer face on several the columns along the elevation. The cracking appears most evident to the top of the columns to level 4 and above, which is currently undecorated.

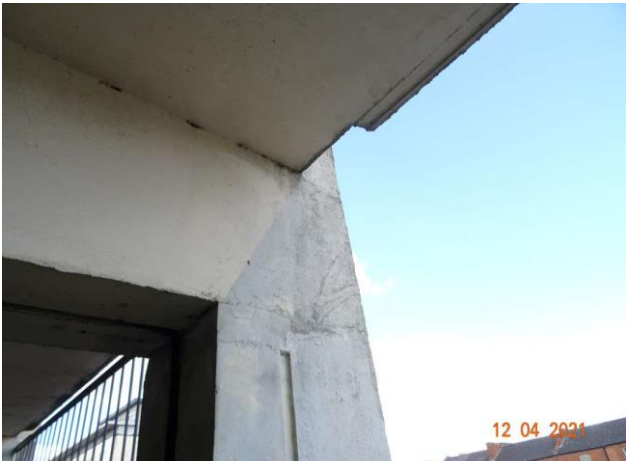
**Photo No. 20**

- 5.2.3.1 To the soffit of level 2, there was no significant change in the condition of the existing crack, and only a few minor new corrosion stains evident. The number of corrosion stains appears to be significantly less than what was viewed on the ground and first floor to the soffits. **(Photograph. No 19)**
- 5.2.3.2 To the soffit of level 3, slight cracking and corrosion staining were most evident to the soffit of the ramp in the centre of the structure and the ramp leading up to level 4. **(Photograph. No 20)**

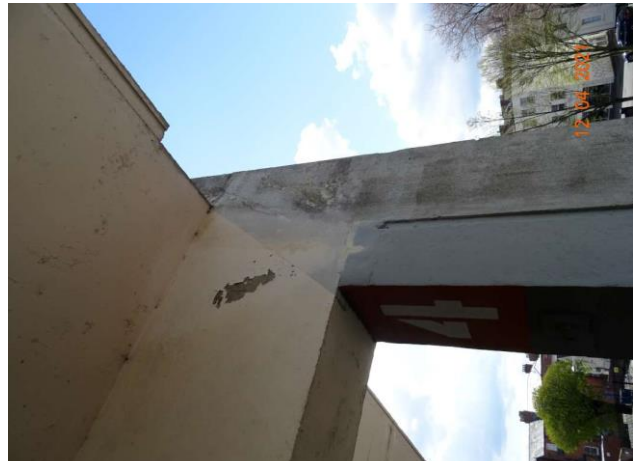
**Photo No. 21**

- 5.2.4.1 Several new slight horizontal and diagonal cracks are now evident to the external outside face of several the columns near the head of the column connection to the beam on both level 4 and 5 to East and West elevations. **(Photograph. No 21 - 23)**
- 5.2.4.2 Existing cracks on level 4 and 5 to soffits and decks appear visually to be the same and have not deteriorated.
- 5.2.4.3 Several new slight cracks appeared to be evident to the soffit at the outer edge to level 5. **(Photograph. No 24)**
- 5.2.4.4 Exposed steel reinforcement is now visible in several locations to the soffit on level 4 due to spalling concrete.

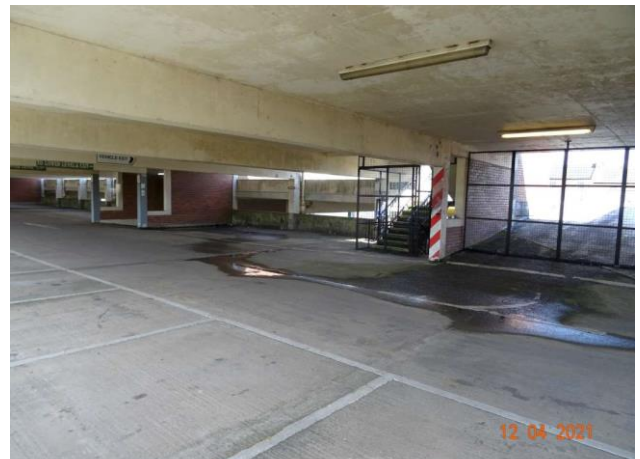
**Photo No. 27**

5.2.5.1 Several new slight horizontal and diagonal cracks are now evident to the external outside face of some of the columns on both level 4 and 5 **(Photograph. No 27)**
